The Deal Lake 2010 319(h) Implementation Project Final Report Grant # RP10-088

Prepared by:

Princeton Hydro, LLC
P.O. Box 720
1108 Old York Road, Suite 1
Ringoes, New Jersey 08551
(P) 908.237.5660
(F) 908.237.5660
www.princetonhydro.com
*Offices in New Jersey, Pennsylvania
and Connecticut*

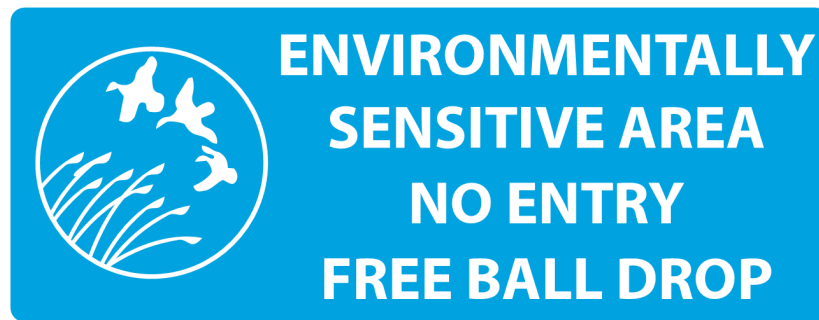
Down to Earth Landscaping of Jackson, New Jersey constructed the three CTGC basins. Their bid totaled \$98,657.50, which was significantly less than the \$110,000 - \$120,000 estimated for this project in the grant application. Down to Earth Landscaping initiated work on the project by early December 2012 and completed the work before the re-opening of the course in May 2013. Project oversight was provided by Princeton Hydro and close communication was maintained with Ocean Township DPW and the Department of Recreation & Human Services. Out-of-bounds signs were erected along the perimeter of each basin informing the golfers that the basins were environmentally sensitive areas and entry was prohibited. Two large educational signs were posted, one in the clubhouse and one alongside the Hole 7 bio-infiltration swale detailing the purpose and benefits of the basins.
